Laboratory Focus

Investigating Uneven and Very Slow Microplate Evaporation Phenomena

Induka Abeysena, Genevac Ltd

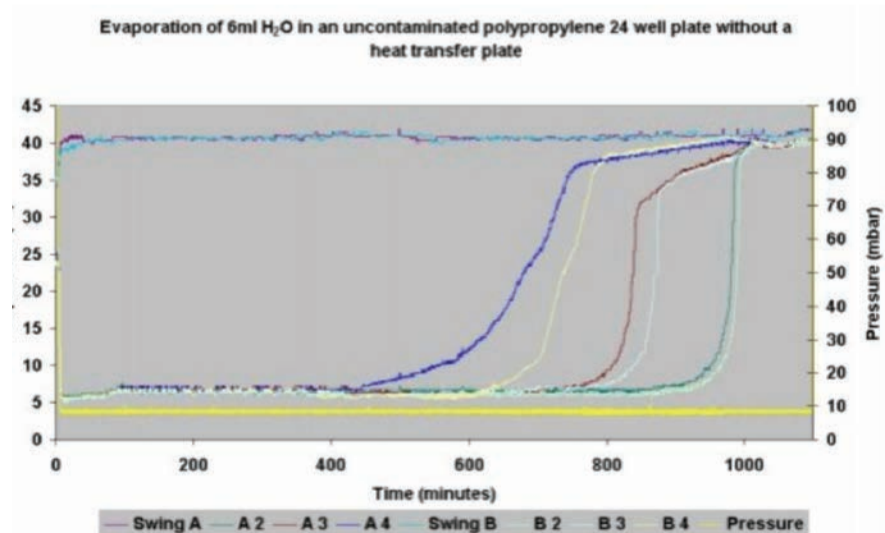
Figure 2

Microplates from manufacturer M2 (see Figure 2), dried as expected and showed no adverse effects. In this experiment the boiling temperature of water held at about 4°C at 8mbar until the all the water was completely evaporated.

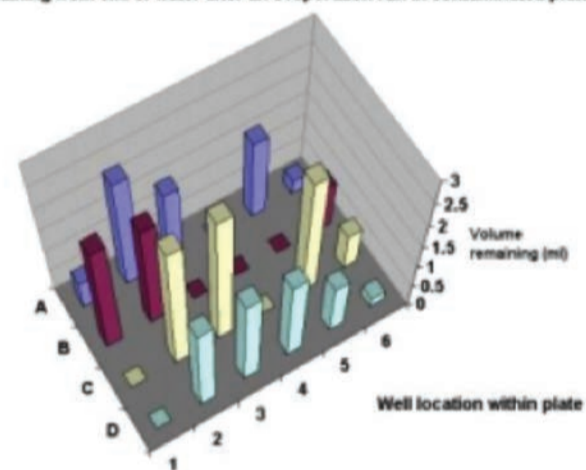
However, in similar experimental conditions, microplates from manufacturer M1 did not dry as expected. Figure 3 below illustrates the volume of water left in each well at the end of the run and Figure 4, shows the graph of the boiling temperature vs pressure curve against time.

Solvent remaining from 6ml of water after an evaporation run in contaminated plates

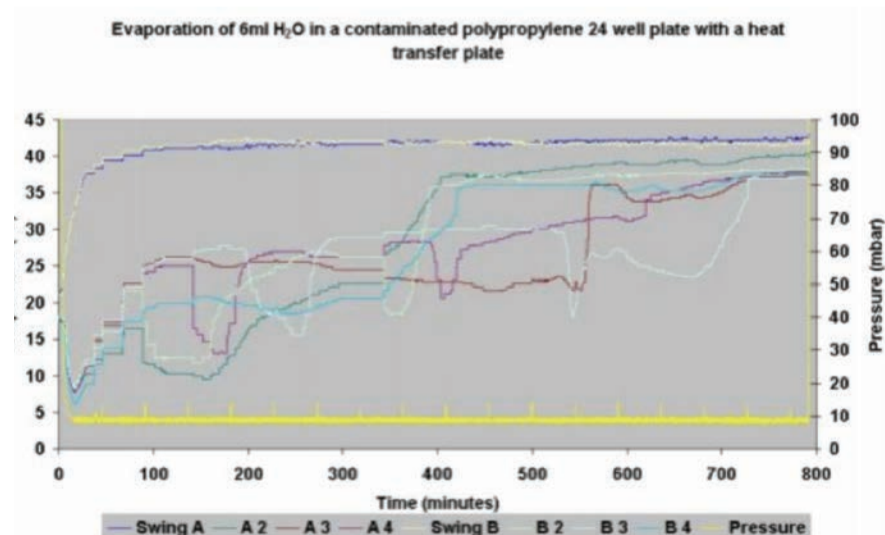
The uneven drying of the manufacturer microplate M1, might be explained by contaminant film formation on the surface of the water hindering evaporation. Figure 4 shows fluctuation of the sample temperature at 8mbar. The uneven results indicate that the sample being evaporated was not pure water and that film formation arising from microplate M1 hindered the water evaporation resulting in an elevated sample temperature.

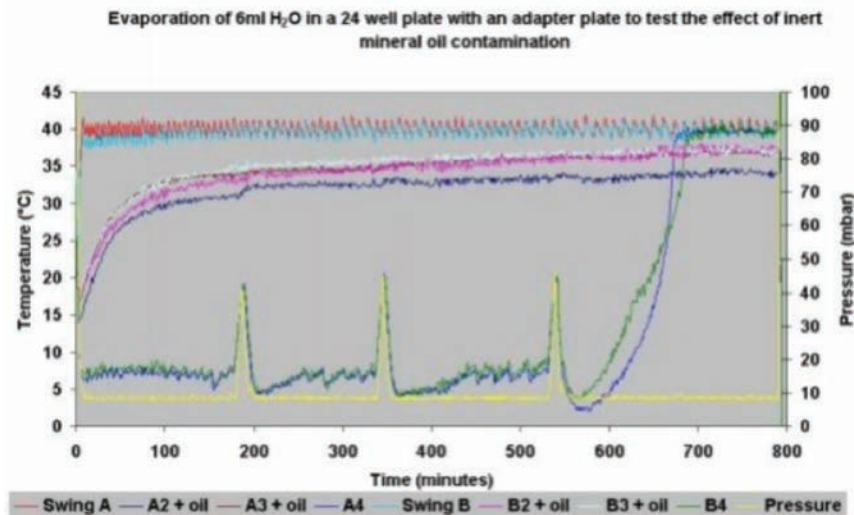
In further experiments to simulate the effect of contamination, we added a small amount of an inert mineral oil to some wells of a microplate from manufacturer M2 along with 6ml of water. Results from this evaporation experiment are shown in Figure 5 below.

It is clear from a comparison of Figure 5 (induced contamination) with those of Figure 4 (genuine contamination) that the effects are similar. The induced contamination gave results closely following those of the contaminated, unwashed plates i.e. they exhibiting elevated solvent temperatures during drying, and left some microplate wells wet. The induced contamination is clearly more severe than that which occurs when using the contaminated microplates from Manufacturer M1. This is likely because the naturally occurring contaminants were present at lower levels than the gross induced contamination.
